SITE NAME: Nagy Auto Body EPA ID# OH005048459

**PRELIMINARY ASSESSMENT/
VISUAL SITE INSPECTION**

**CLYDE PAINT AND SUPPLY CO.
CLYDE, OHIO
OHD 005 048 459**

Work Assignment No.	:	C05087
EPA Region	:	5
Site No.	:	OHD 005 048 459
Date Prepared	:	October 28, 1992
Contract No.	:	68-W9-0006
PRC No.	:	009-C05087OH81
Prepared by	:	PRC Environmental Management, Inc. (Deb Harrity)
Contractor Project Manager	:	Shin Ahn
Telephone No.	:	(312) 856-8700
EPA Work Assignment Manager	:	Kevin Pierard
Telephone No.	:	(312) 886-4448

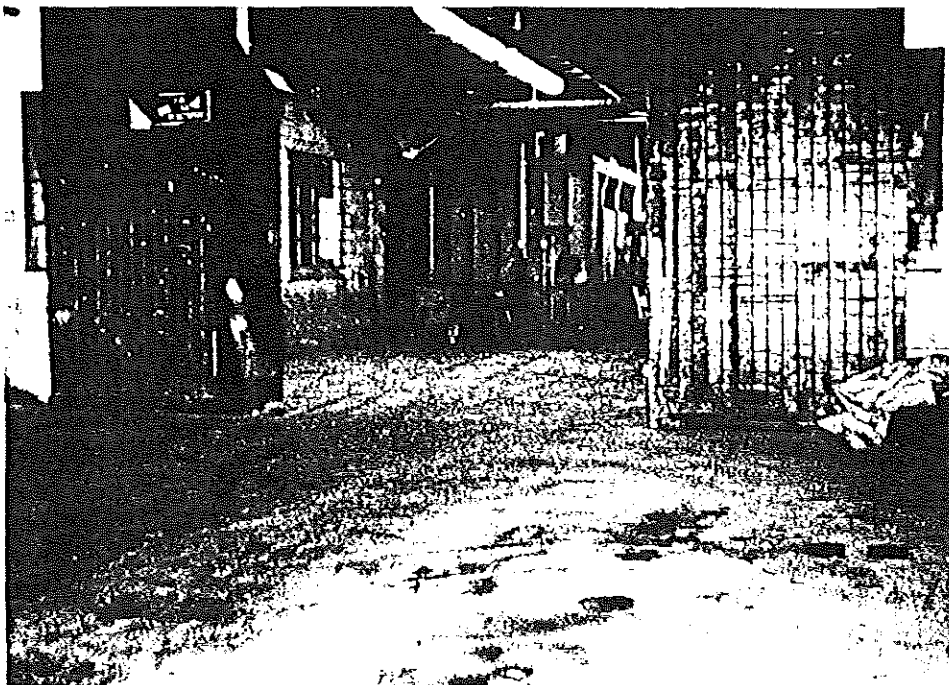
Photograph No. 2
 Orientation: Southeast
 Description: Closed CSA on first floor of recycling building.

Location: SWMU 1
 Date: 05/21/91
